**Report of Phase I Environmental Site  
Assessment**

**Bear Springs Lumber Distribution Facility  
2303 Northwest Front Avenue  
Portland, Oregon**

**August 27, 1996**

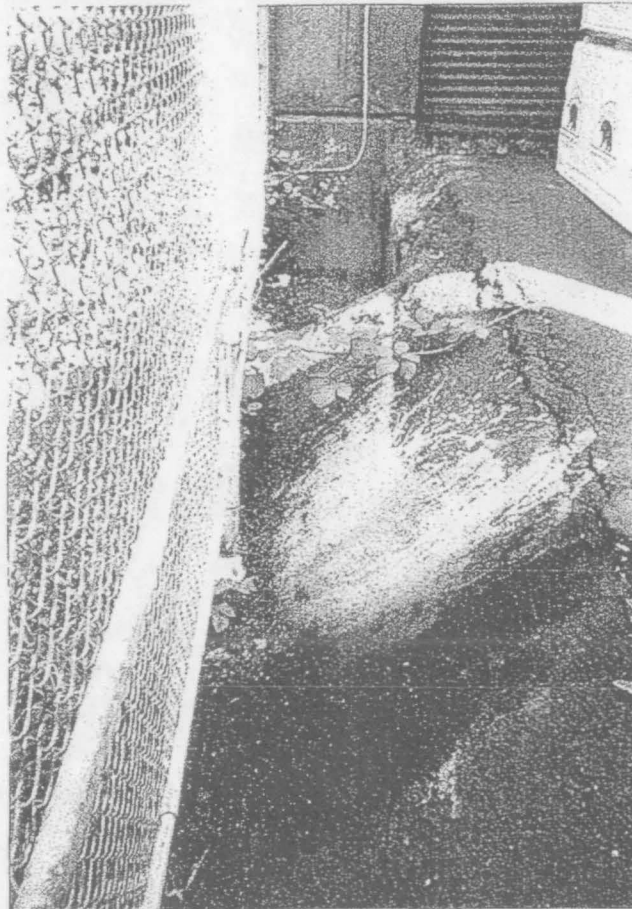
View of the paint stains located outside the southeast corner of the warehouse.

Some minor staining was observed on the asphalt pavement in the truck loading areas and driveways and on the concrete floors inside the warehouse. The staining outside the warehouse appeared to be typical of truck and automobile traffic on site. The staining inside the warehouse appeared to be from forklifts. Some minor stains were observed on the floor in the area where the used oil was stored, adjacent to the northeastern truck loading area. Some minor staining was observed on the floor in the maintenance area, wood cutting area and the painting area. An approximately 5-foot by 3-foot area of asphalt located outside the south corner of the warehouse building was stained with paint and a minor amount of a dark, oil-like substance. The staining extended down a slope in the asphalt, beneath a fence and onto a gravel-paved surface.

- Surface staining was observed in a small area in the southern portion of the warehouse and on the asphalt outside the southeast corner of the building, apparently resulting from past paint disposal practices on site. The asphalt surface outside the southeast corner of the building was in poor condition with numerous cracks. Staining on the asphalt extended down a slope, beneath a fence and onto a gravel-paved surface. Current disposal practices include removing the paint and water solution from the subject site. Although interviews suggest that latex paints have been used in the recent past, solvent-based paints could have been used previously on the site. Because of this, we recommend that the Port of Portland obtain near-surface soil samples for chemical analysis in the most heavily paint-stained areas outside the building.

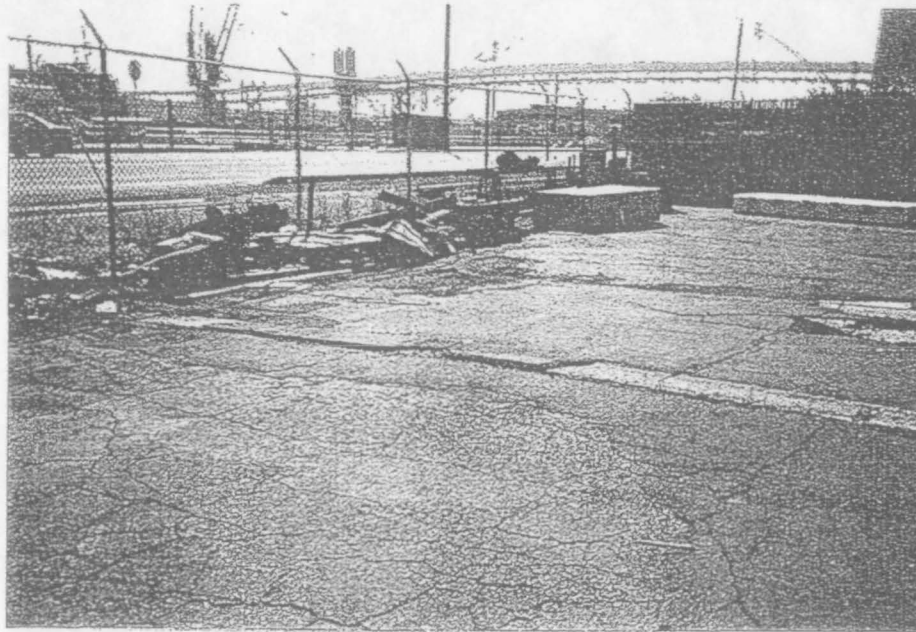
View of the scrap metal, used tires and wooden box debris located in the northeast corner of the subject site.

Some debris was observed in the east corner of the subject site during the site reconnaissance. The debris consisted of scrap metal, used tires and an empty wooden box. No surface staining was observed in the area.
